## Dubai: Regional Case Study Before and After Rain

**Regional Case Study 1 (from Dubai):** On April 16, 2024, the United Arab Emirates experienced an unusual rain event that severely affected many areas, causing significant disruptions to daily life. Dubai, in particular, was hit hard, receiving an entire year's worth of rain within just 12 hours. This extreme weather event, attributed to changing environmental conditions, led to widespread flooding, flight cancellations, and impassable roads. As part of our investigation, we have chosen a specific area in Dubai to study the extent of the impact caused by this intense rainfall. A Sentinel-2 [1] satellite captured imagery with a 10-meter resolution, shown in Figures 1 and 2. The after-rain image taken on April 17, 2024, clearly depicts the extent of water accumulation post-rainfall. This event brings a rapid rise in water levels, disrupting social activities and majorly affecting the roads, as well as critical infrastructure like restaurants, hospitals, schools, malls, etc. Such rain occurrences are relatively uncommon in dry regions like the Emirates, highlighting the significant impact of this natural disaster.

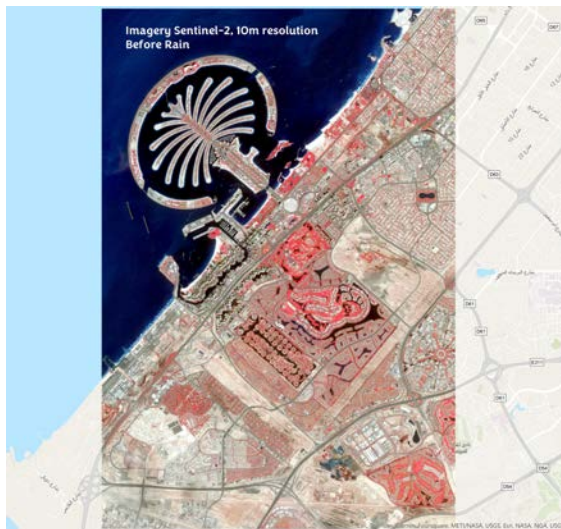
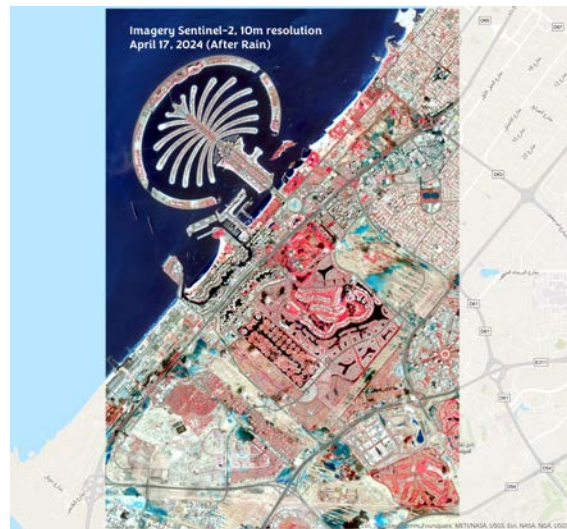
Figure 1: Before Rain

Figure 2: After Rain

We have used Sentinel-2 imagery for our initial study, which helps us see how rain affects various aspects of society. Following the acquisition, we eliminate clouds from areas where they exist to minimize noise in the data. This process is crucial because it helps ensure that the data we gather is as accurate as

possible. By removing clouds, we can reduce interference and better analyze the information we obtain. By comparing images before and after the rain, we can identify roads impacted by water accumulation, shown as yellow lines overlapping flooded areas. We also mark a 200-meter radius around such areas to pinpoint key spots like malls, schools, markets, food places, and hospitals to see how they are affected. The number of affected structures includes 460 cafes & restaurants, 75 hospital facilities, 116 stores, 11 schools & universities, and 4 malls. In our case study patch in Dubai, there are 2,963 kilometers of mapped roads out of a total of 18,800 kilometers [2] in the city. From our analysis, we found that 140 kilometers out of 2,963 kilometers are impacted by rain, including primary, residential, service, and highways. We also assess how residential and industrial areas are affected by rainfall. Our data comes from OpenStreetMap, where volunteers worldwide contribute geographic information like streets, points of interest, and landmarks. Furthermore, our analysis involved the application of machine learning technique to extract the built-up area, revealing that 6 km<sup>2</sup> of this area was inundated out of a total of 94 km<sup>2</sup>. This observation indicates that approximately 6.4% of the built-up area was affected by the flooding event. Figure 3 can be seen for a summary of our findings in our case study area.

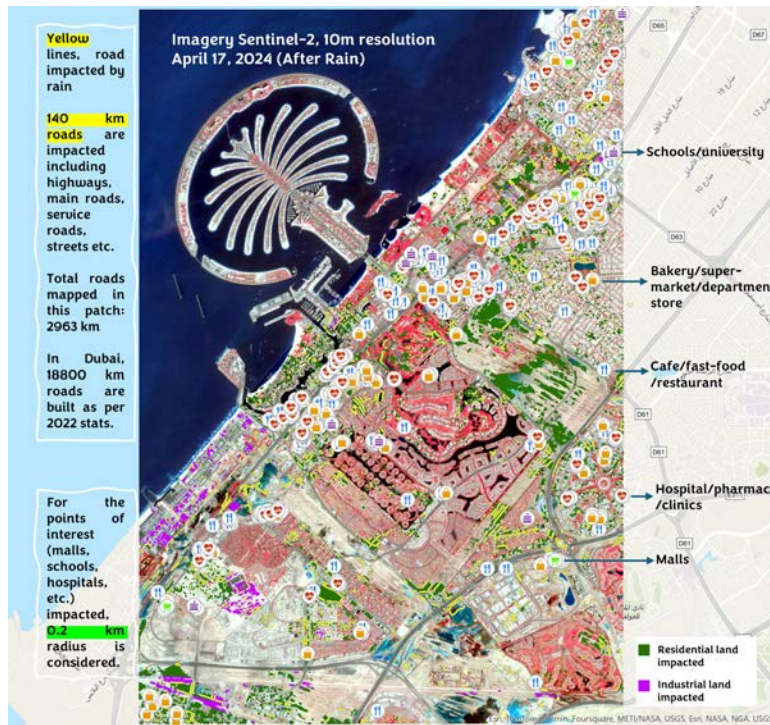
Figure 3: Analysis: Region for our case study.

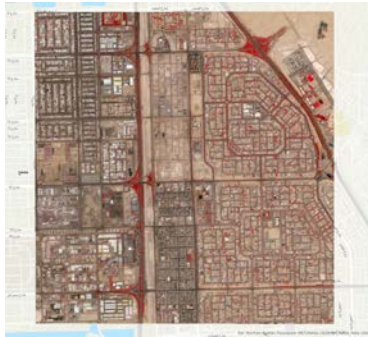
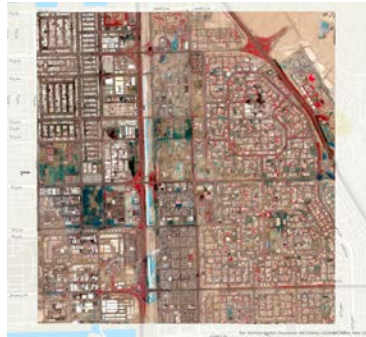
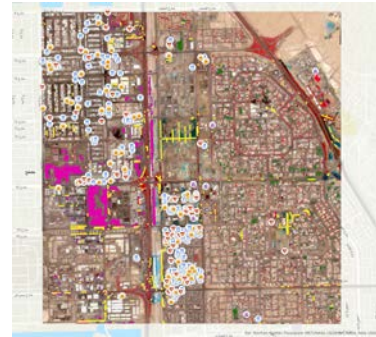
**Regional Case Study 2 (from Abu Dhabi):** The April 16 weather system also impacted Abu Dhabi and neighboring regions. Our study expands its focus to specific regions within Abu Dhabi, leveraging data from sources such as Sentinel-2 imagery dated April 17, 2024. This examination unveiled widespread impacts on critical infrastructure, including schools, hospitals, and restaurants within a 200-meter radius. To ensure precision, regions covered by clouds in the images were substituted with noise-free data. Numerous vital facilities were impacted, along with approximately 21 kilometers of road, out of a total

network spanning 837 kilometers, sustaining damage across various categories of roads. Furthermore, we meticulously computed the number of eateries, medical facilities, retail outlets, and educational institutions affected, revealing a potential disruption in the operations of 240 restaurants & cafes, 55 healthcare facilities, 78 stores, and 6 educational institutions. Employing machine learning techniques, we outlined the built-up areas in the Sentinel-2 imagery. We observed that approximately 2 km<sup>2</sup> of land within a 40 km<sup>2</sup> area was flooded, signifying a flooding extent of 5% in the targeted region of Abu Dhabi.

Figure 4: Before Rain

Figure 5: After Rain

Figure 6: Analysis: Case Study

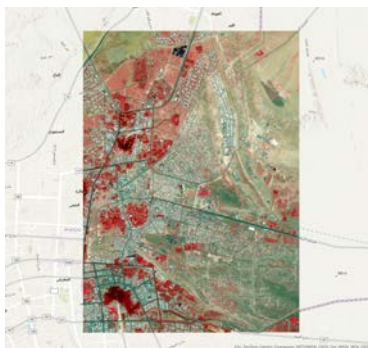
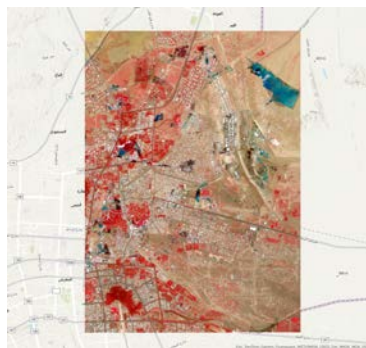
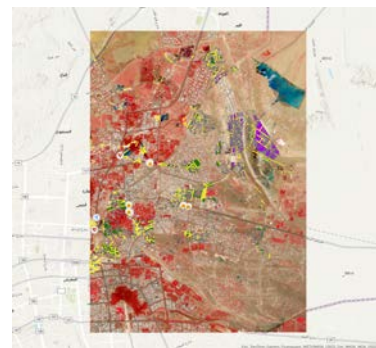
**Regional Case Study 3 (from Oman):** In our comprehensive analysis, we have expanded our investigation to include the impact of rainfall on regions beyond the Emirates, specifically focusing on the area in the Oman region close to the Al Ain border. We found that out of a total road network spanning 1270 kilometers, 58 kilometers of roads have suffered damage across different types of roads due to abnormal rains. Additionally, we assessed the impact on some important facilities, finding potential disruptions in the operations of 5 restaurants and cafes, 2 healthcare facilities, and 7 stores. The potential danger is comparatively lower given the relatively limited residential facilities and commercial places in this border area. Leveraging machine learning techniques, we analyzed Sentinel-2 imagery to identify built-up areas. We observed that approximately 5 km<sup>2</sup> of land within an 88 km<sup>2</sup> area experienced flooding, indicating a flooding extent of 5.7% in the targeted region of Oman.

Figure 7: Before Rain

Figure 8: After Rain

Figure 9: Analysis: Case Study
